CENTENNIAL COAL Angus Place ANNUAL REVIEW

May 2023

Name of Operation	Angus Place Colliery
Name of Operator	Centennial Angus Place Pty Ltd
Development Consent/ Project Approval #	MP06_0021
Name of holder of Development Consent/ Project Approval	Centennial Angus Place Pty Ltd
Mining Lease #	ML1323, ML1326, (part) ML1424, ML1699, ML1720, MPL314, CCL702, CCL704, EL6856, EL6293, EL7415, EL8188, MLA498.
Name of Holder of Mining Lease	Centennial Springvale Pty Ltd and Boulder Mining Pty Ltd
Water License #	WAL36445; WAL36449; WAL37340; WAL37343; WAL41881
Name of Holder of Water License	Centennial Angus Place Pty Ltd
RMP Start Date	July 2022
RMP End Date	NA
Annual Review Start Date	1 January 2022
Annual Review End Date	31 December 2022

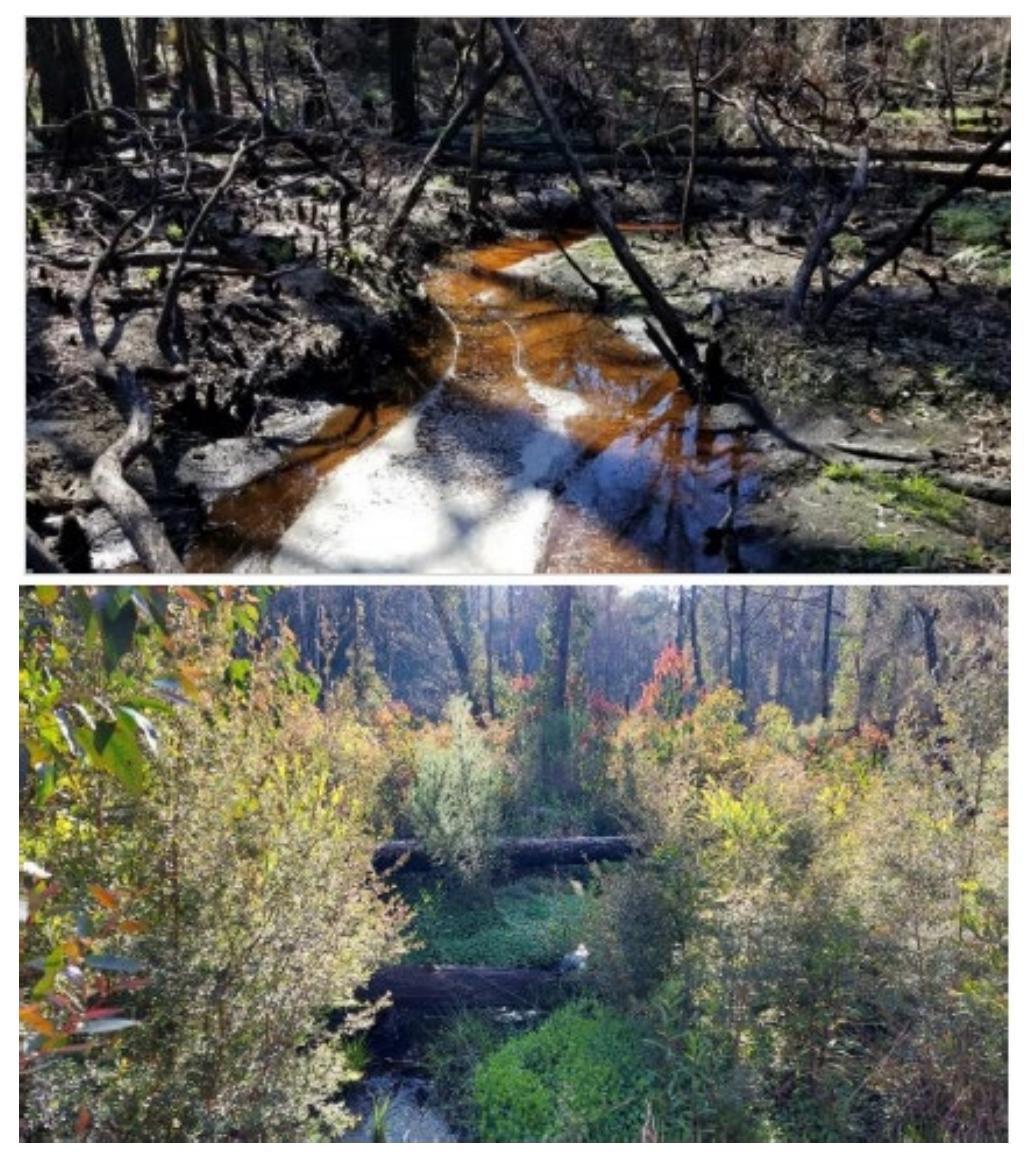
Plate 6-1: Aquatic ecology monitoring site KC1 in Autumn 2020 (top) and spring 2022, highlighting recovery after bushfire and high rainfall in 2022.

dense coverage of understorey vegetation including native shrubs, grasses and ferns as shown on **Plate 6-1**. This is likely to have contributed to the improvement in macroinvertebrate results at both sites in 2022, but particularly at KC1 which was most badly damaged. Sensitivity metrics (EPT richness and SIGNAL-2) in particular were much higher than 2020 and 2021 results.

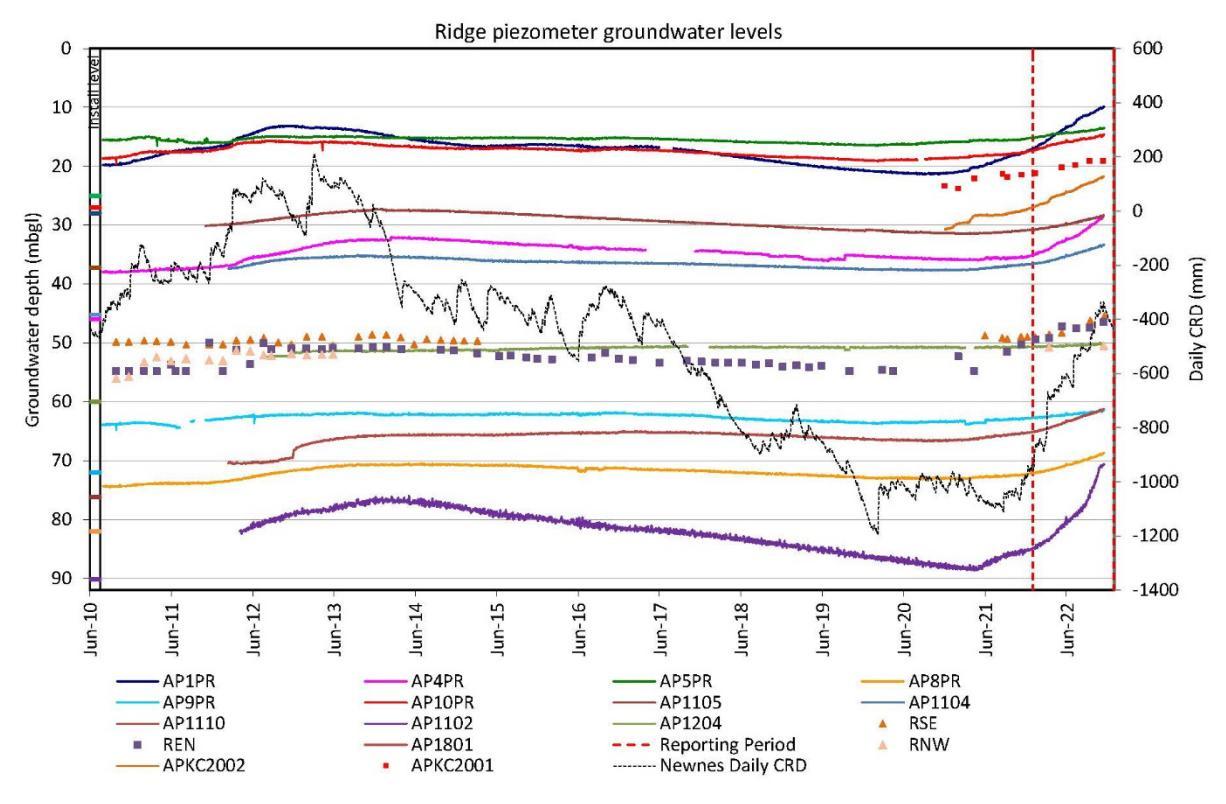
Figure 7-5: Ridge Piezometer Hydrograph

All ridge piezometers, except for RNW which has been dry for some time, show an increasing trend in groundwater level. This is consistent with the CRD and above average rainfall in 2022.

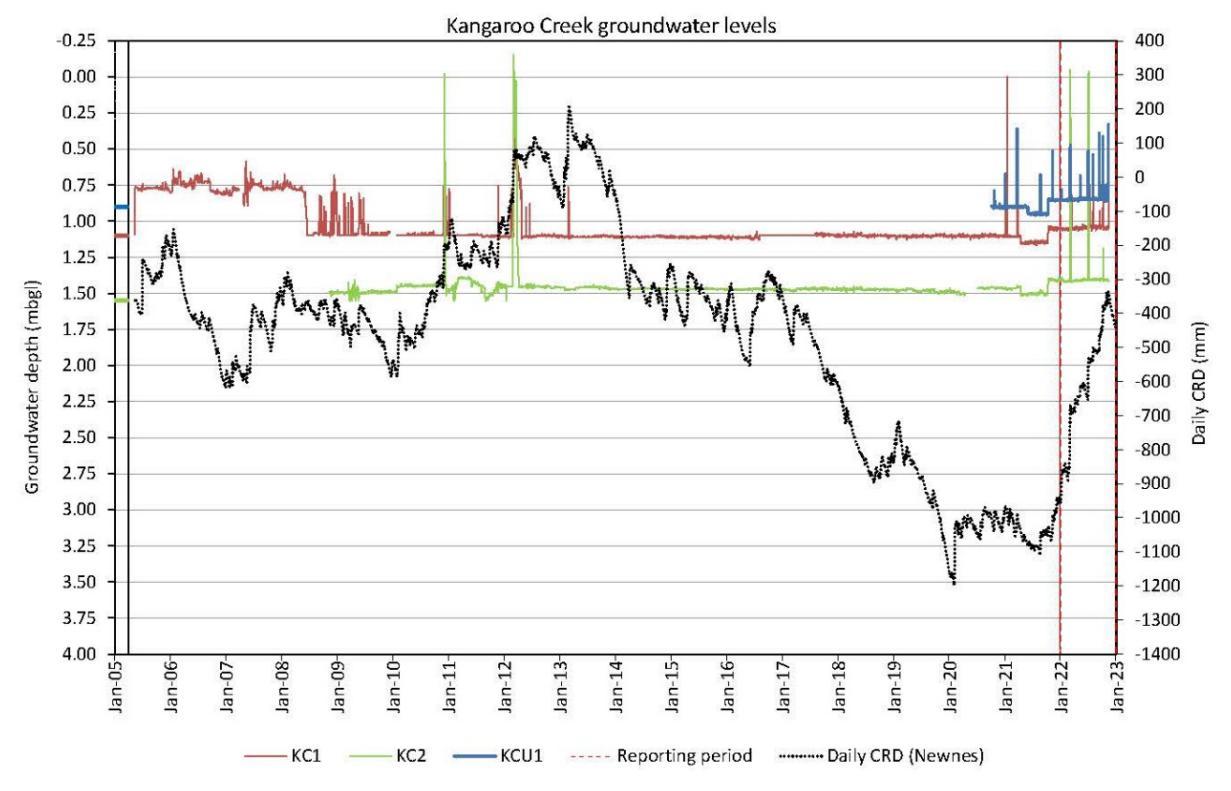
Figure 7-6: Kangaroo Creek Groundwater Levels

During the reporting period, groundwater levels at KC1, KC2 and KCU1 were mostly dry, with immediate and direct responses to significant rainfall events observed at all three monitoring sites. KCU1 displayed a response to rainfall events more frequently than KC1 and KC2. Groundwater levels at all monitoring sites decline quickly after rainfall, indicating groundwater observations are likely through flow.

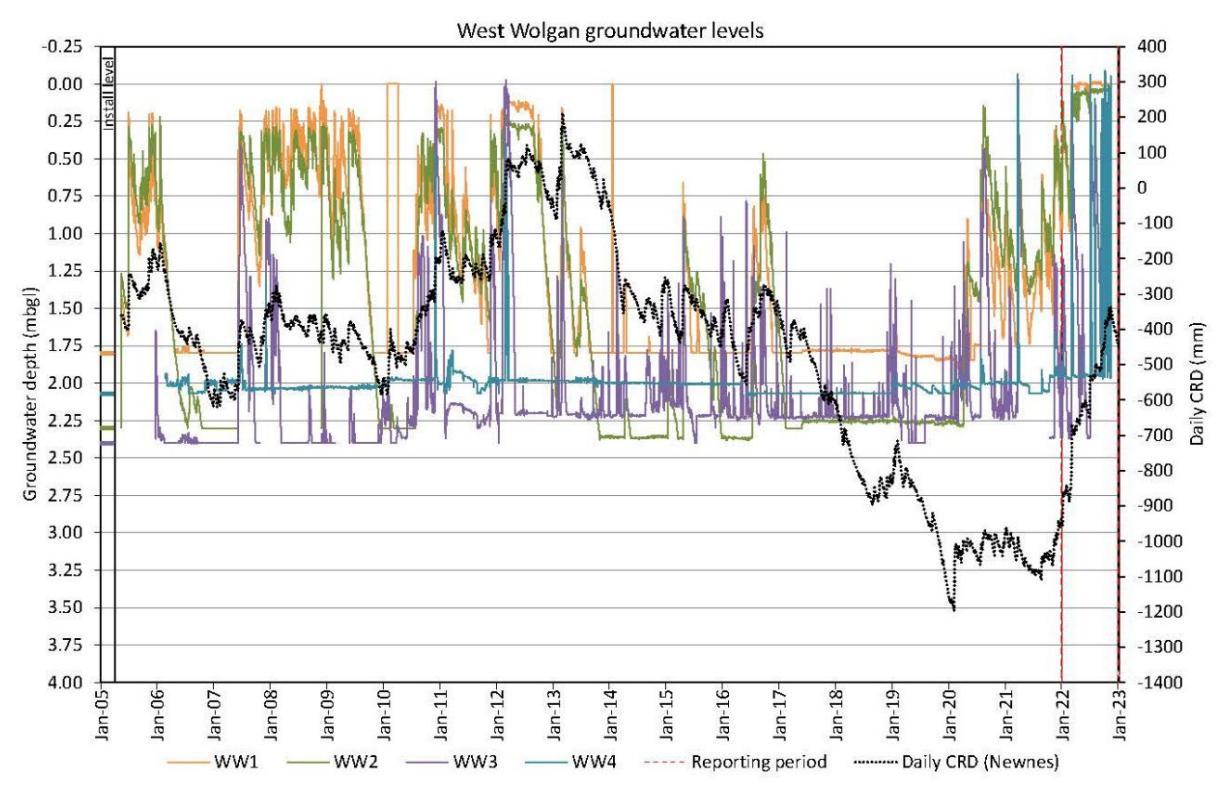
Figure 7-8: West Wolgan Groundwater Levels

During the reporting period, groundwater levels at WW1 and WW2 increased in March 2022 as a response to the increasing CRD trend and remained relatively stable just below ground level. Groundwater levels at WW3 and WW4 fluctuated in response to rainfall events. Groundwater at WW4 drained quickly and was predominately dry between rainfall events, while groundwater at WW3 did not drain as quickly and fewer dry periods were observed. The quickly declining groundwater level at WW4 indicates groundwater observations are likely through flow.

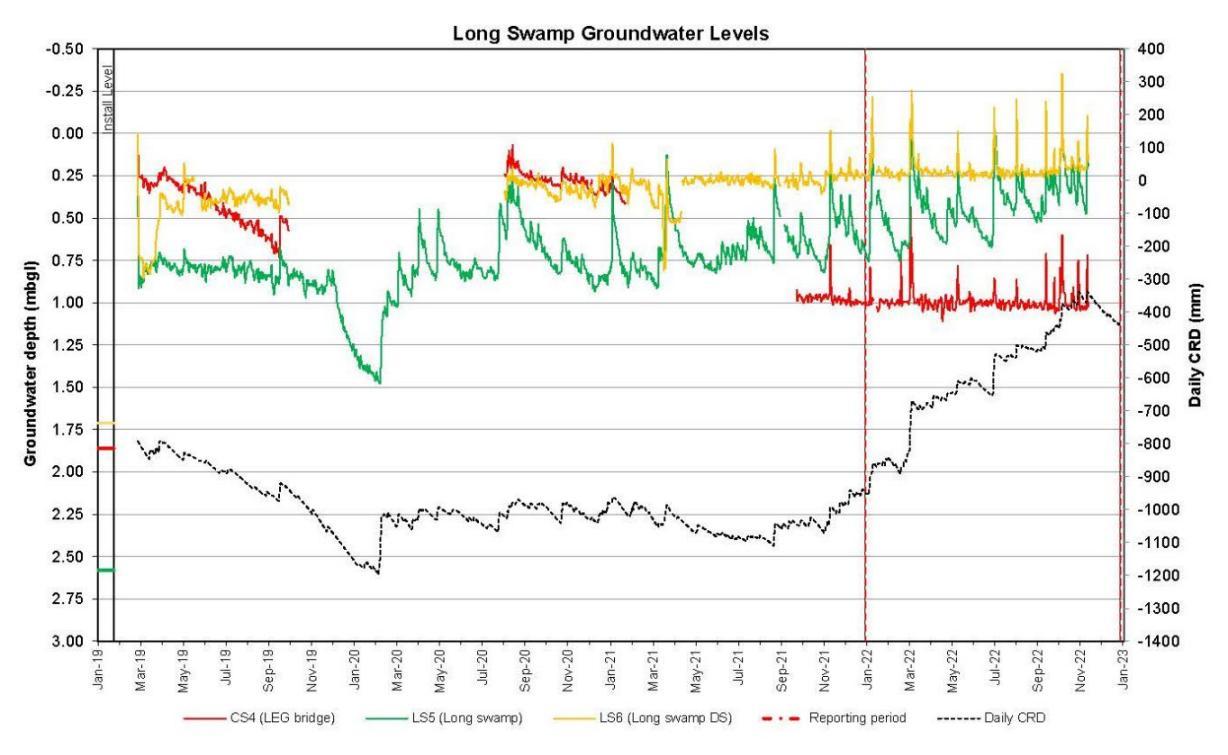
Figure 7-13: Long Swamp Groundwater Levels

During the reporting period, groundwater levels at CS4 and LS6 remained relatively stable with direct and immediate increases in groundwater level as a response to rainfall recharge. The groundwater level at LS5 also increased in immediate response rainfall recharge, with a longer groundwater level decay.
